## STRUCTURAL MONITORING OF THE NINFEO PONARI BY FIBRE OPTIC SENSORS, PHOTOGRAMMETRY AND LASER SCANNING

## ABSTRACT

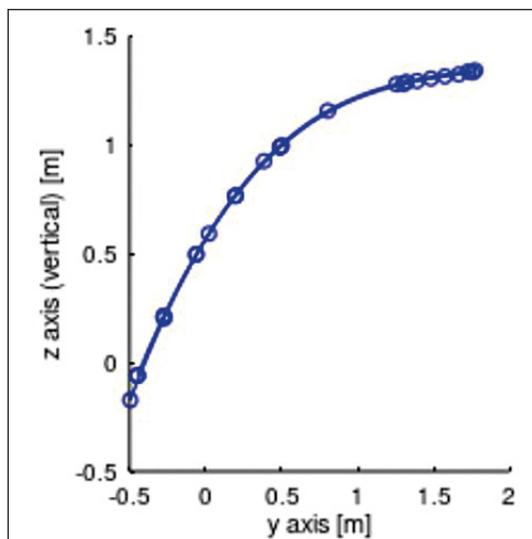
Fig. 4 – Spline fit of part of the vault at one section.

Survey of untreated surface is done with robotised scanning. Scan of the full surface is done with a large number of robotised small-surface scans, progressively moving the total station to have each scan with quasi-perpendicular incidence angle, thus achieving the best working condition. For each scan, the position of the total station is evaluated with respect to the 9 reflective targets, thus working out a cloud of points of the whole building. The cloud of points is processed to retrieve a polygonal 3D mesh. In processing, smoothing is done to filter minor local effects (surface roughness, cracks, tile/plaster detachments, etc.) which are of no interest with respect to the macro-deformations induced by the geotechnical mechanism. Most interest focuses on the vertical sections parallel to the bottom wall, which are of maximum precision as all the points used to work out each of them come from the same robotic scanning. Fig. 3 shows the full cloud of points. Fig. 4 shows an example of the result of the fit procedure: dots are EDM data from

part of the vault at a section along the X axis (Y-Z vertical plane); full line is the fitted spline.

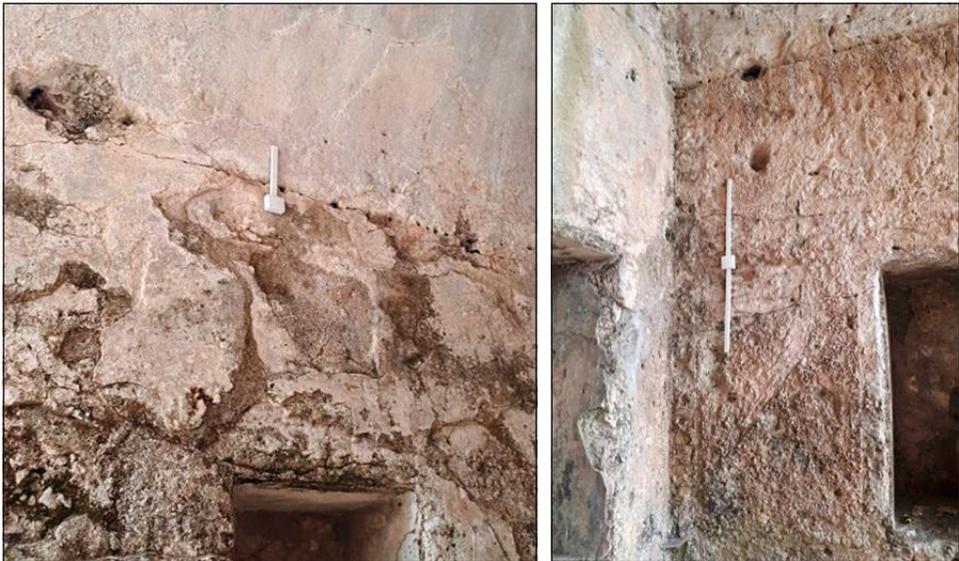
Fig. 5 – Two of the FBGs installed at two major cracks.

Fig. 5 shows two of the installed FBGs. The crackmeters were produced, calibrated and connected in series at the ENEA Research Centre of Frascati. Crackmeters were produced with built-in temperature compensation capability, that is, in each crackmeter two FBGs are present: one FBG is in structural contact with the active component of the crackmeter, and thus it

senses both temperature and strain; the other FBG is in thermal contact only with the active component of the crackmeter; strain is evaluated by differential measurement of the signal of the two FBGs; the measure of the crack opening is encoded in the strain evaluation (variation of the crack opening modifies the strain of the active component of the crackmeter). Up to the date of the submission of this paper, crackmeters were installed but no long term monitoring was done yet. After installation, crackmeters were tested with a four-days long continuous acquisition, expected to point out the effect of the circadian thermal excitation. As an example of the result of the test, Fig. 6 shows the time history of two crackmeters placed along the same crack, with evidence of the circadian cycle of the opening of the crack at the two monitored locations.
